# Evaluation of the XLTA® Dressing Through a Retrospective Clinical Case Study

Anthony Colonna, DPM James Lin, D.O. & George M. Munro, LPN

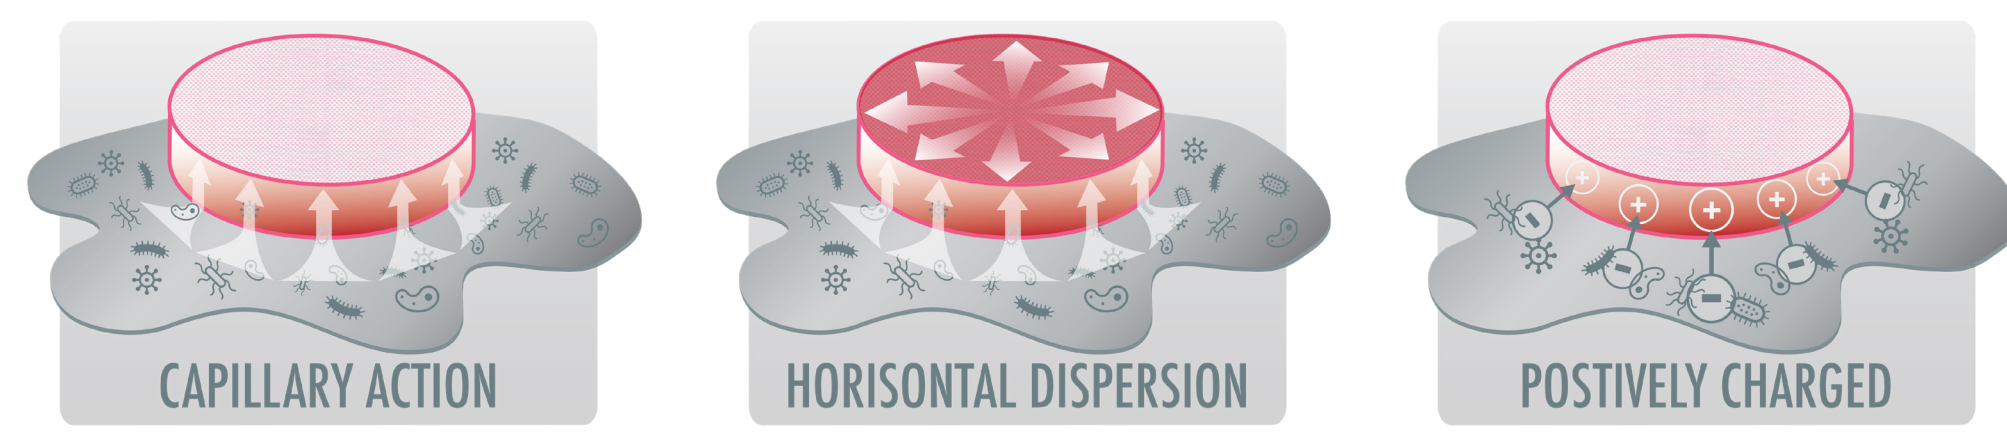
Figure 1. Proposed mechanisms of action for the XLTA® dressing

The XLTA® dressing works through a few proposed mechanisms of action

- **Capillary Action:** Draws in excessive exudate, providing optimal moisture levels for epithelialization
- **Horizontal Dispersion:** Evenly distributed fluid matrix across dressing surface, prevents pooling of fluid and traps bacteria and necrotic tissue away from the wound bed
- **Positively Charged Fibers:** Attract negatively charged bacteria, cytokines, and matrix metalloproteinases (MMPs), which aid in debridement and help to reduce bioburden

The XLTA® dressing aims to provide an alternative option within the advanced wound dressing space. This dressing is an **innovative and novel hydroconductive, hydrocapillary wound dressing with promising clinical results.** It is specifically designed for high exudate management and enhanced wound bed preparation. The XLTA® dressing is composed of **three layers:**

- **Two outer non-adherent layers,** engineered to maximize patient comfort and allow for easy placement and removal.
- **A medial hydrocapillary, super absorbent layer,** responsible for rapid exudate uptake

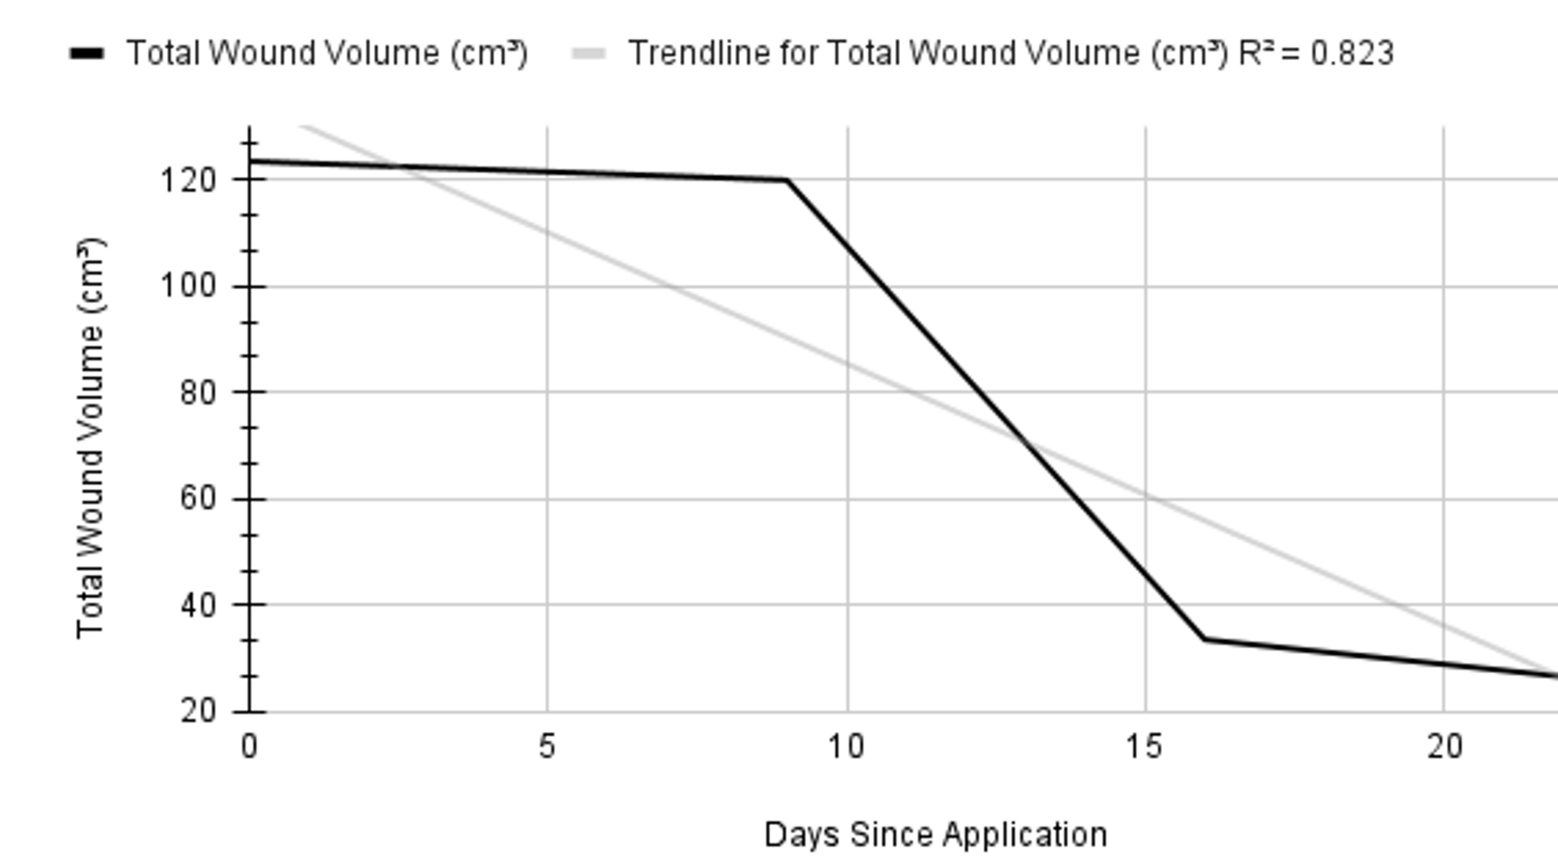
Chart 2. Total Wound Volume in cm<sup>3</sup> with trendline

### Progression of Total Wound Volume

GC's wound initially presented as non-healing with a surface area of **411.25 cm<sup>2</sup>** and a volume of **123.38 cm<sup>3</sup>**, containing significant non-viable slough. After 9 days of treatment with weekly debridement and a hydrocapillary dressing, the wound showed early signs of improvement, with wound volume decreasing by 2.86%, indicating the beginning of granulation and slough reduction.

By day 16, the **wound's progression accelerated noticeably.** The surface area decreased to 336 cm<sup>2</sup> (83% of the original size), while the wound volume dropped sharply to 33.6 cm<sup>3</sup>, only 29% of the initial volume. This substantial volumetric improvement corresponded with a reduction in depth and the appearance of healthy granulation tissue.

By day 23, the **wound had transitioned to a graft-ready state, with a surface area of 255 cm<sup>2</sup>** and a volume of **25.5 cm<sup>3</sup>.** Overall, this reflects a **37.99% reduction in surface area** and a **79.33% reduction in volume** from baseline. Across the three-week period, the wound demonstrated a **mean closure rate of approximately 6.8% per week**, highlighting consistent and meaningful healing progression.

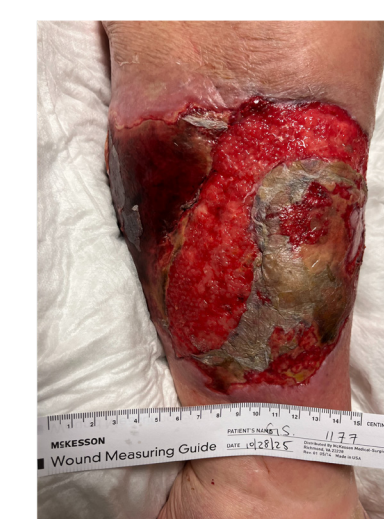
### Image 1 – 28 October 2025:

- Initial visit
- 15.5 × 23.5 × 0.3 cm

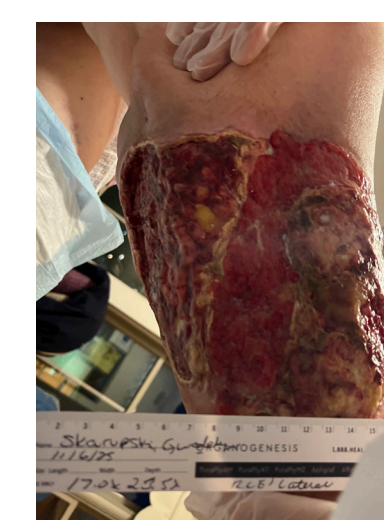
### Image 2 – 06 November 2025:

- 17.0 × 23.5 × 0.3 cm

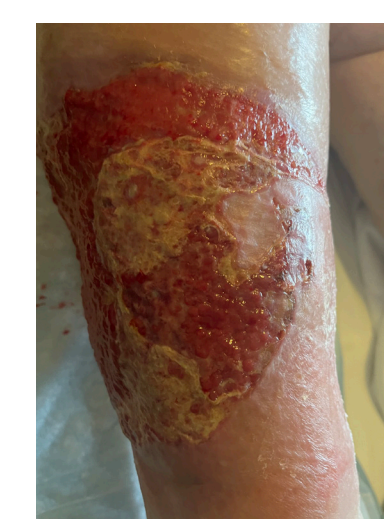
### Image 3 – 13 November 2025:

- 16.0 × 21.0 × 0.1 cm

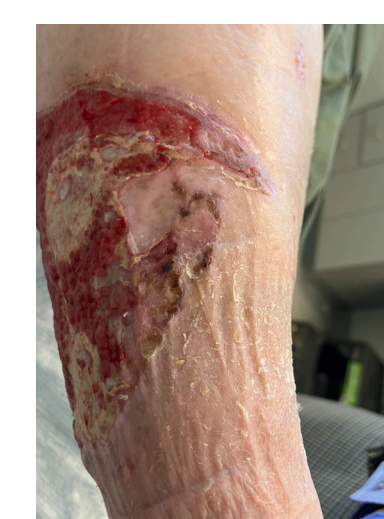
### Image 4 – 20 November 2025:

- 15.0 × 17.0 × 0.1 cm
- Note 100% reduction in non-viable autolyzing achieved
- Dermal skin graft substitute applied on this date

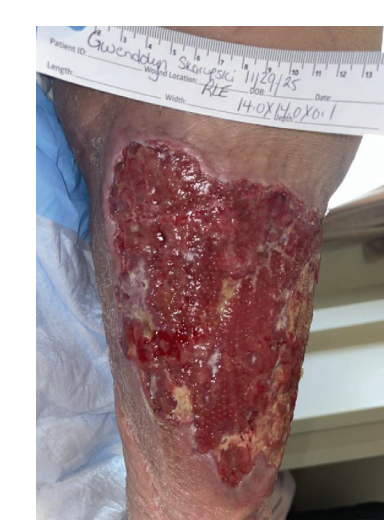
### Image 5 – 29 November 2025:

- 15.0 × 17.0 × 0.1 cm

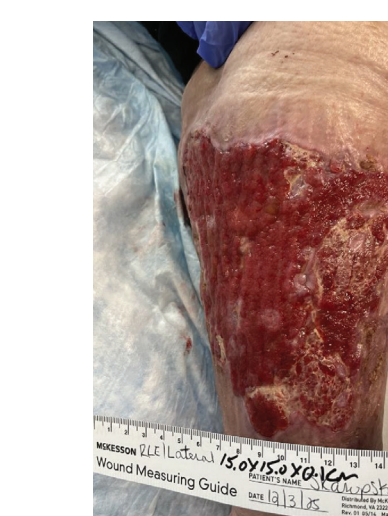
### Image 6 – 12 December 2025:

- 15.0 × 15.0 × 0.1 cm
- Note 100% increase in size is visually noted due to fragile epithelial tissue along the edges in photo dated 11/29/2025 being mechanically debrided during the cleansing and wound prepping process
