Multimodal Thermal and Fluorescence Imaging in Advanced Wound Care: A Case Series Using an All-In-One Wound Imaging Device

Rose Raizman,^{1,2} Ron Linden,³ Laura M. Jones-Donaldson,⁴ Danielle Dunham⁴

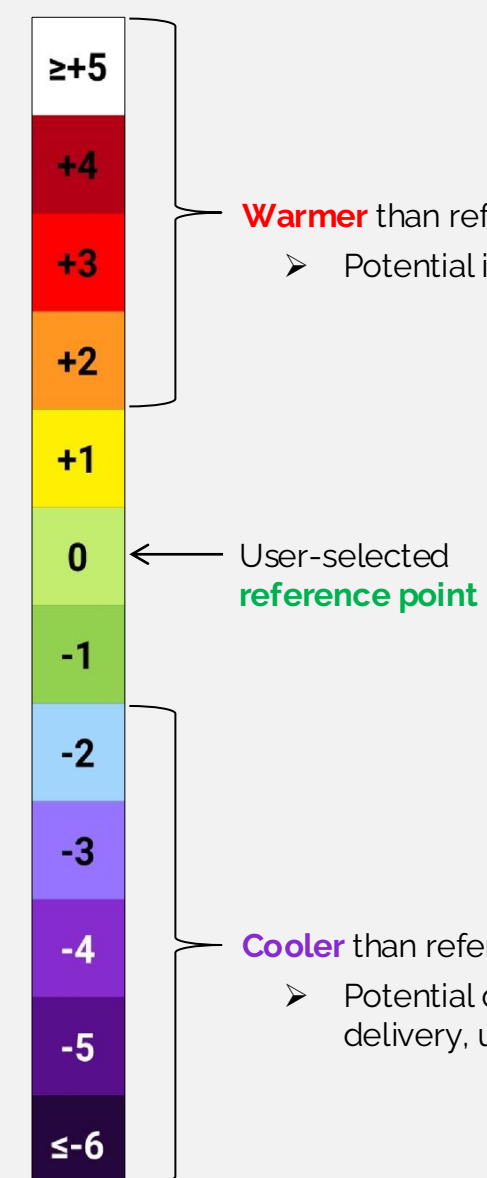
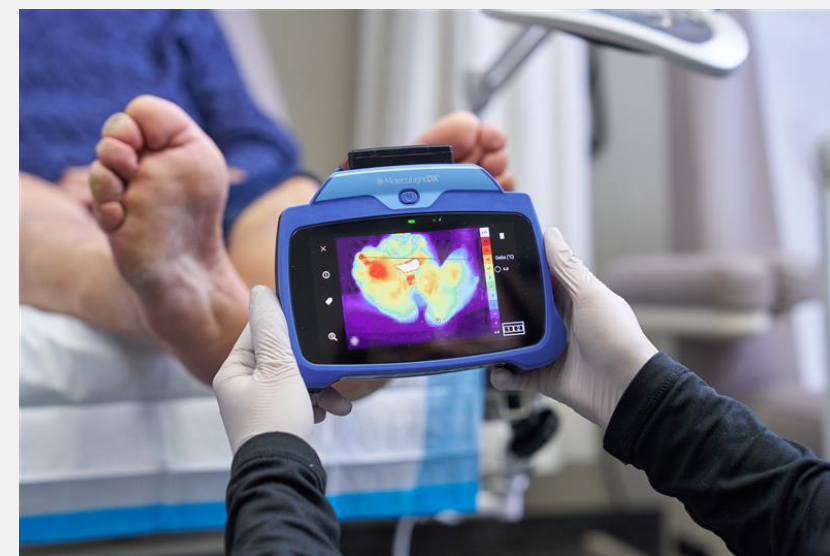
- Chronic, stalled wounds were imaged using the MolecuLightDX[®]+ imaging device (MolecuLight Inc., Toronto, Ontario, Canada), yielding real-time co-registered standard, fluorescence and thermal images and auto-calculations of temperature differences (ΔT) between two user-selected regions.

Integers along the scale denote differences in temperature (°C) relative to the reference point

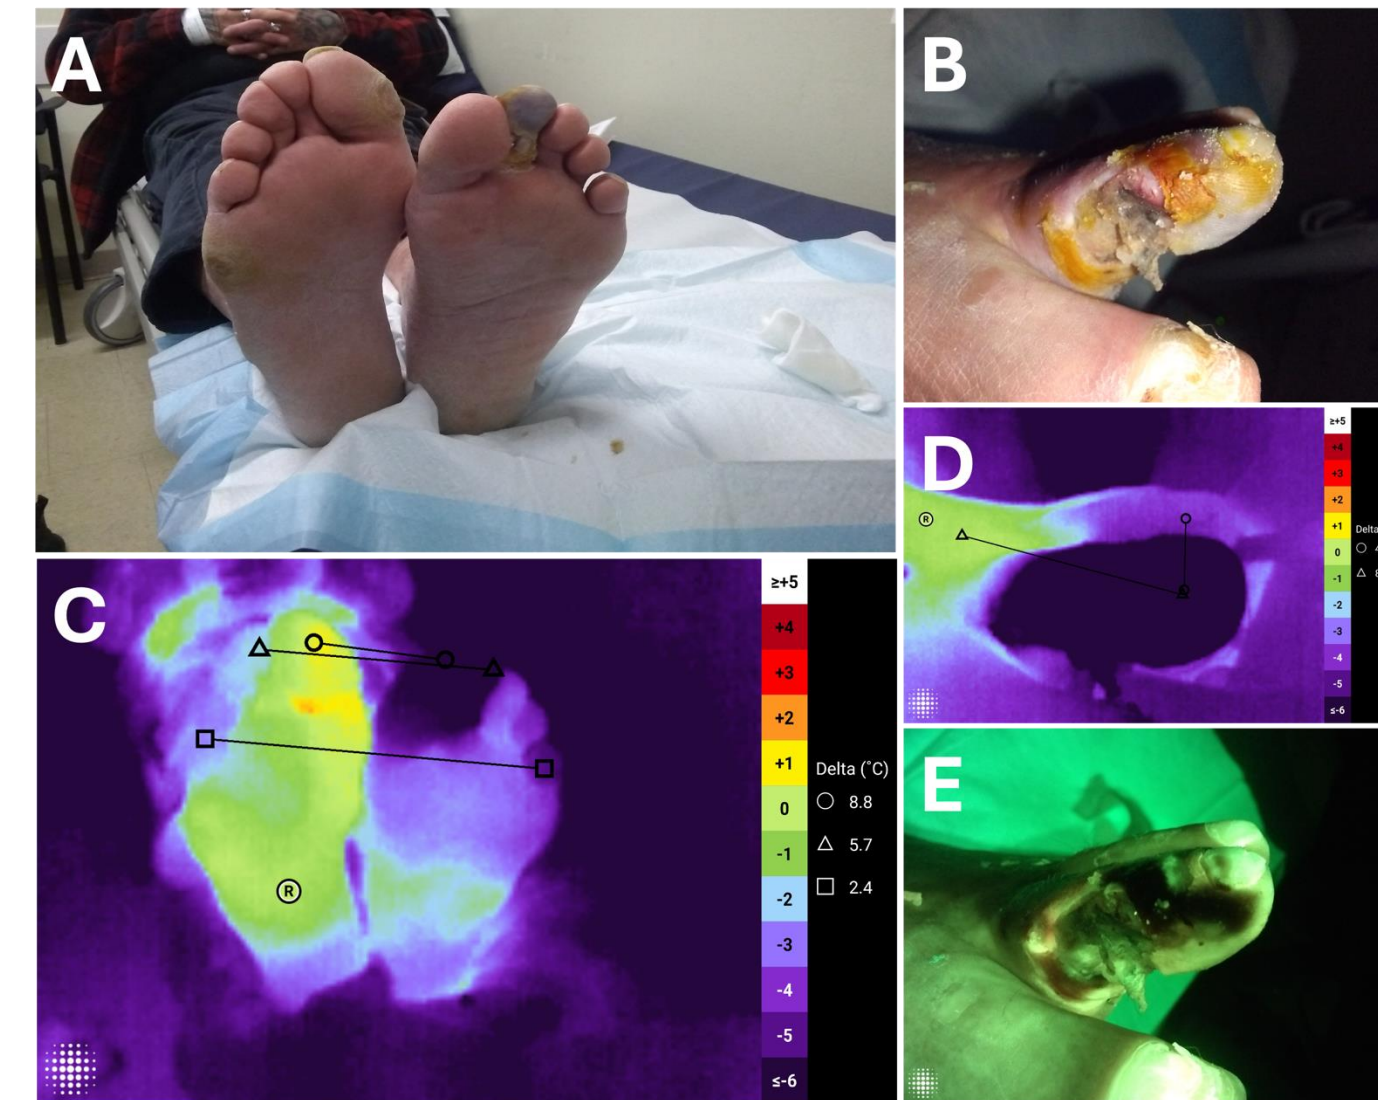
Case 1: Detecting unseen vascular impairment

Case summary: A 60-year-old male with diabetes presented with a 6-week chronic left foot ulcer. Standard assessment showed visible cyanosis of the second toe consistent with ischemia, while the first toe appeared clinically intact (A, B). Thermal imaging showed that the second toe was 5.7°C cooler and the great toe 8.8°C cooler than the contralateral limb (C, D), suggestive of significant blood flow impairment not apparent during the initial clinical assessment. No elevated bacterial signal was detected (E).

Findings: Imaging findings prompted immediate vascular referral and intervention.

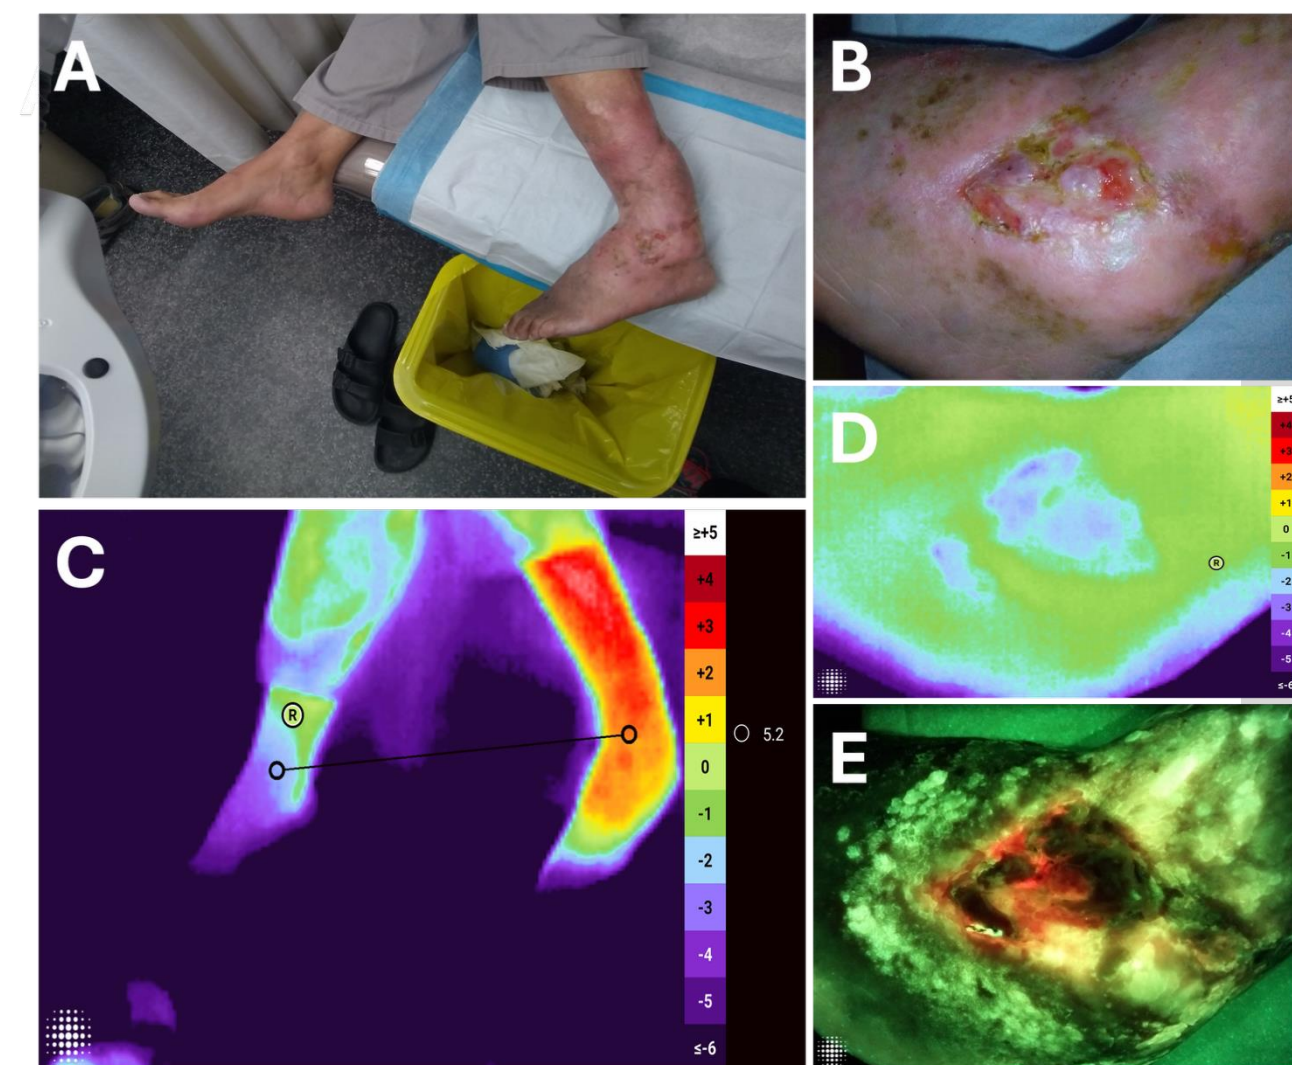
Case 3: Supporting infection detection and treatment response

Case summary: A 62-year-old male with a 35-year chronic traumatic right ankle wound and prior reconstructive surgeries (A, B) underwent multimodal imaging. Thermal imaging showed the affected ankle was 5.2°C warmer than the contralateral limb (C, D), suggestive of infection. Fluorescence imaging revealed red signal along the wound edges (E), consistent with elevated bacterial burden; microbiology confirmed *Staphylococcus aureus*. Systemic antibiotics and a silver dressing were initiated.

Findings: Multimodal imaging supported infection identification and enabled monitoring of treatment response.

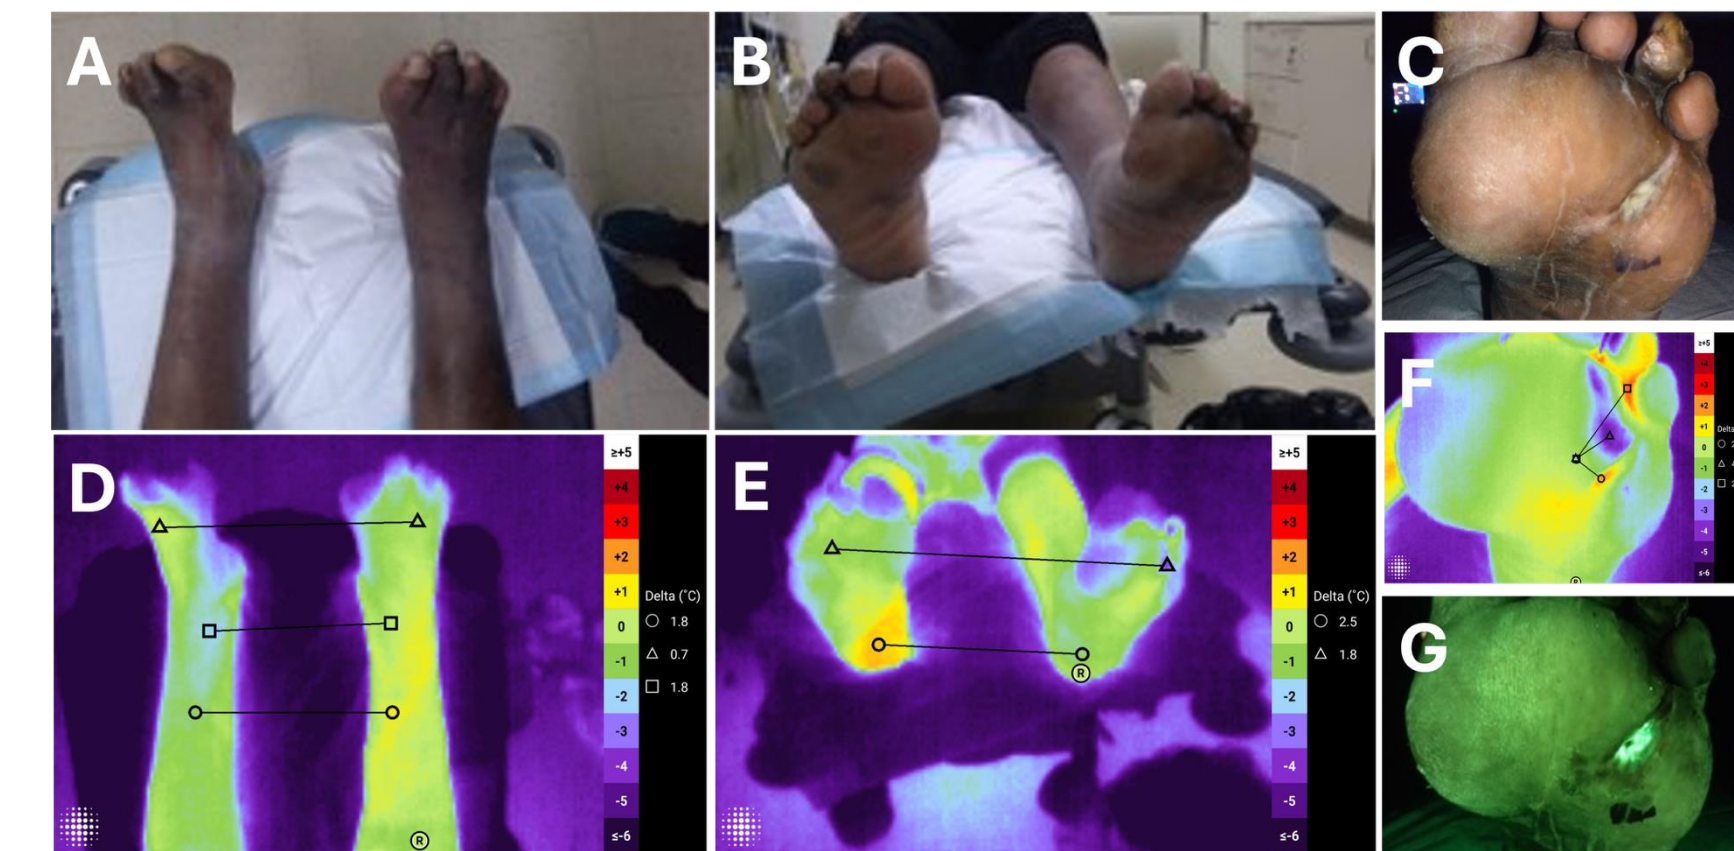
Case 2: Detecting hidden tunneling

Case summary: A 38-year-old male with type 2 diabetes presented with a chronic plantar wound without overt clinical signs of infection (A-C). Thermal imaging showed a small bilateral ΔT (1.8°C) (D, E) but identified a 4.0°C cooler zone within the wound bed (F), suggestive of a deep tunneling tract not evident clinically. Fluorescence imaging revealed cyan signal (G), consistent with *Pseudomonas aeruginosa*, confirmed by microbiology.

Findings: Multimodal imaging identified tunneling and bacterial burden, enabling targeted structural and antimicrobial intervention.

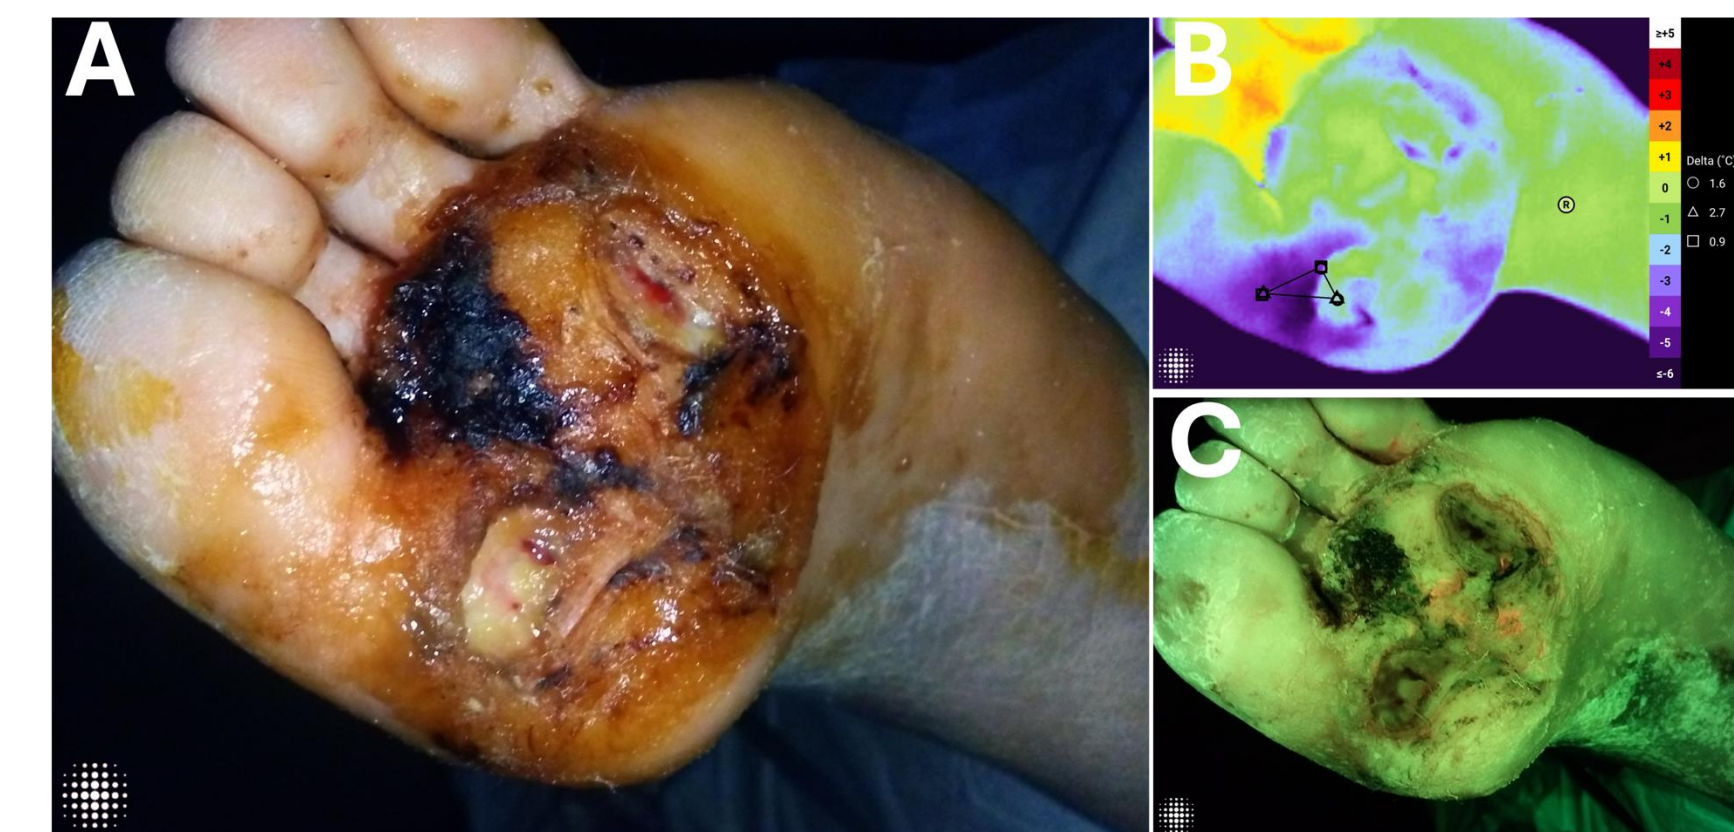
Case 4: Detecting hidden undermining

Case summary: A patient with diabetes, recently hospitalized for myocardial infarction, underwent multimodal wound assessment. Thermal imaging identified a focal cooler region beneath the great toe (B), suggestive of sub-surface undermining. Fluorescence imaging revealed bluish red signal beneath the skin surface (C), consistent with clinically significant bacterial burden. Findings raised concern for possible osteomyelitis, prompting further evaluation while systemic antibiotics continued.

Findings: Multimodal imaging guided targeted management and ongoing monitoring for potential bone infection.
