The Use of MolecuLight in Hidradenitis Suppurativa: A Case Series Exploring Point-of-Care Bacterial Imaging

Star-Kayla Lewis,^{1,2,3} Amit S. Rao,² Alisha Oropallo,^{1,2,3}

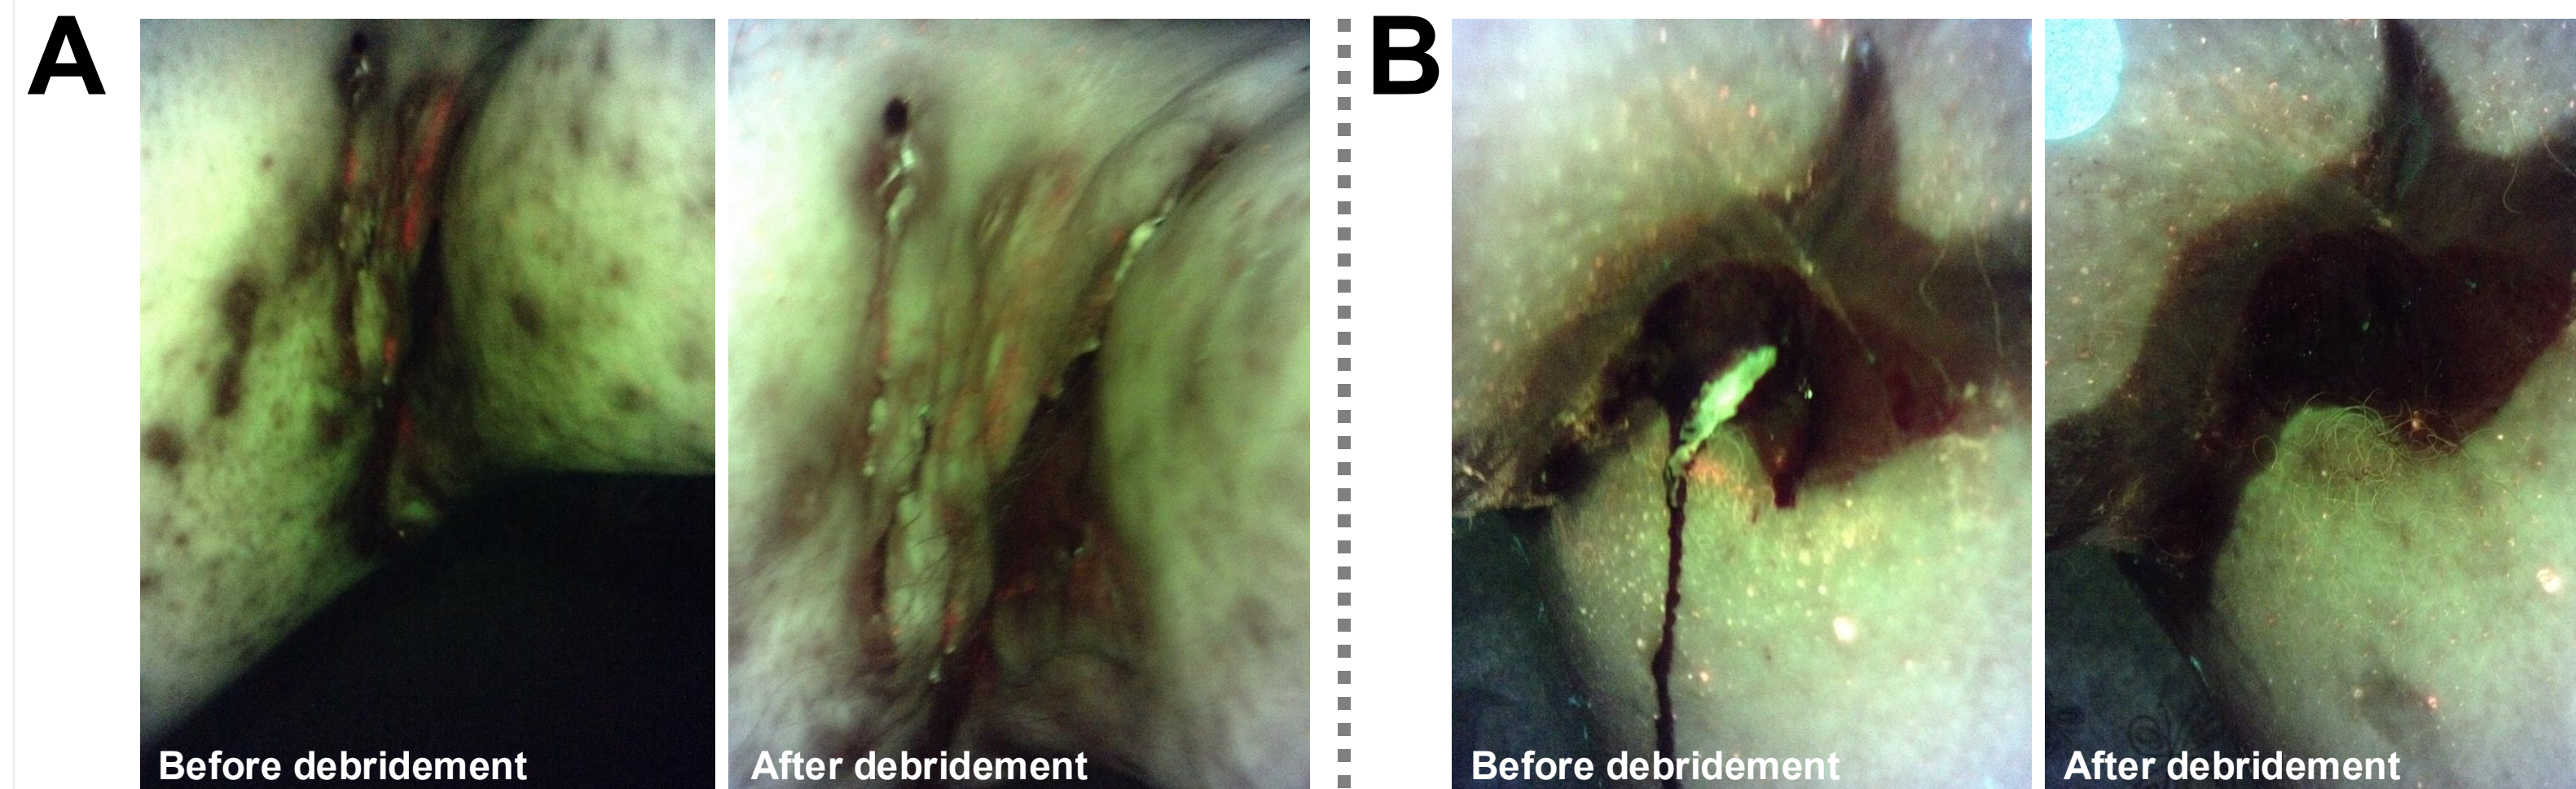
Case 1: Fluorescence-Guided Management of Bilateral Axillary HS Wounds

Case summary: A 17-year-old male with bilateral axillary HS underwent staged surgical and wound management supported by BFI. (A) Fluorescence imaging showed red fluorescence in the left axilla, consistent with elevated bacterial burden. Following wound cleansing, the fluorescence signal persisted, indicating that washout alone was insufficient. Mechanical debridement was performed, resulting in a reduction in fluorescence signal, demonstrating decreased bacterial burden. (B) At follow-up (7 weeks after last visit), the left axillary wound had remained persistent. Fluorescence imaging again showed red fluorescence. As in the prior visit, cleansing alone did not reduce fluorescence, while mechanical debridement resulted in a visible decrease in fluorescence signal, reinforcing the role of targeted debridement when washout alone was insufficient. At the last visit (~30 weeks of follow-up), the wound showed gradual improvement with intermittent drainage and pain during care. The patient was longitudinally monitored for infection risk using bacterial fluorescence imaging with the MolecuLight i:X, with ongoing debridement and antimicrobial wound care as needed.

Finding: Fluorescence imaging provided point-of-care visualization of bacterial burden and showed that mechanical debridement rather than cleansing alone was required to effectively reduce bacterial fluorescence in this HS wound.

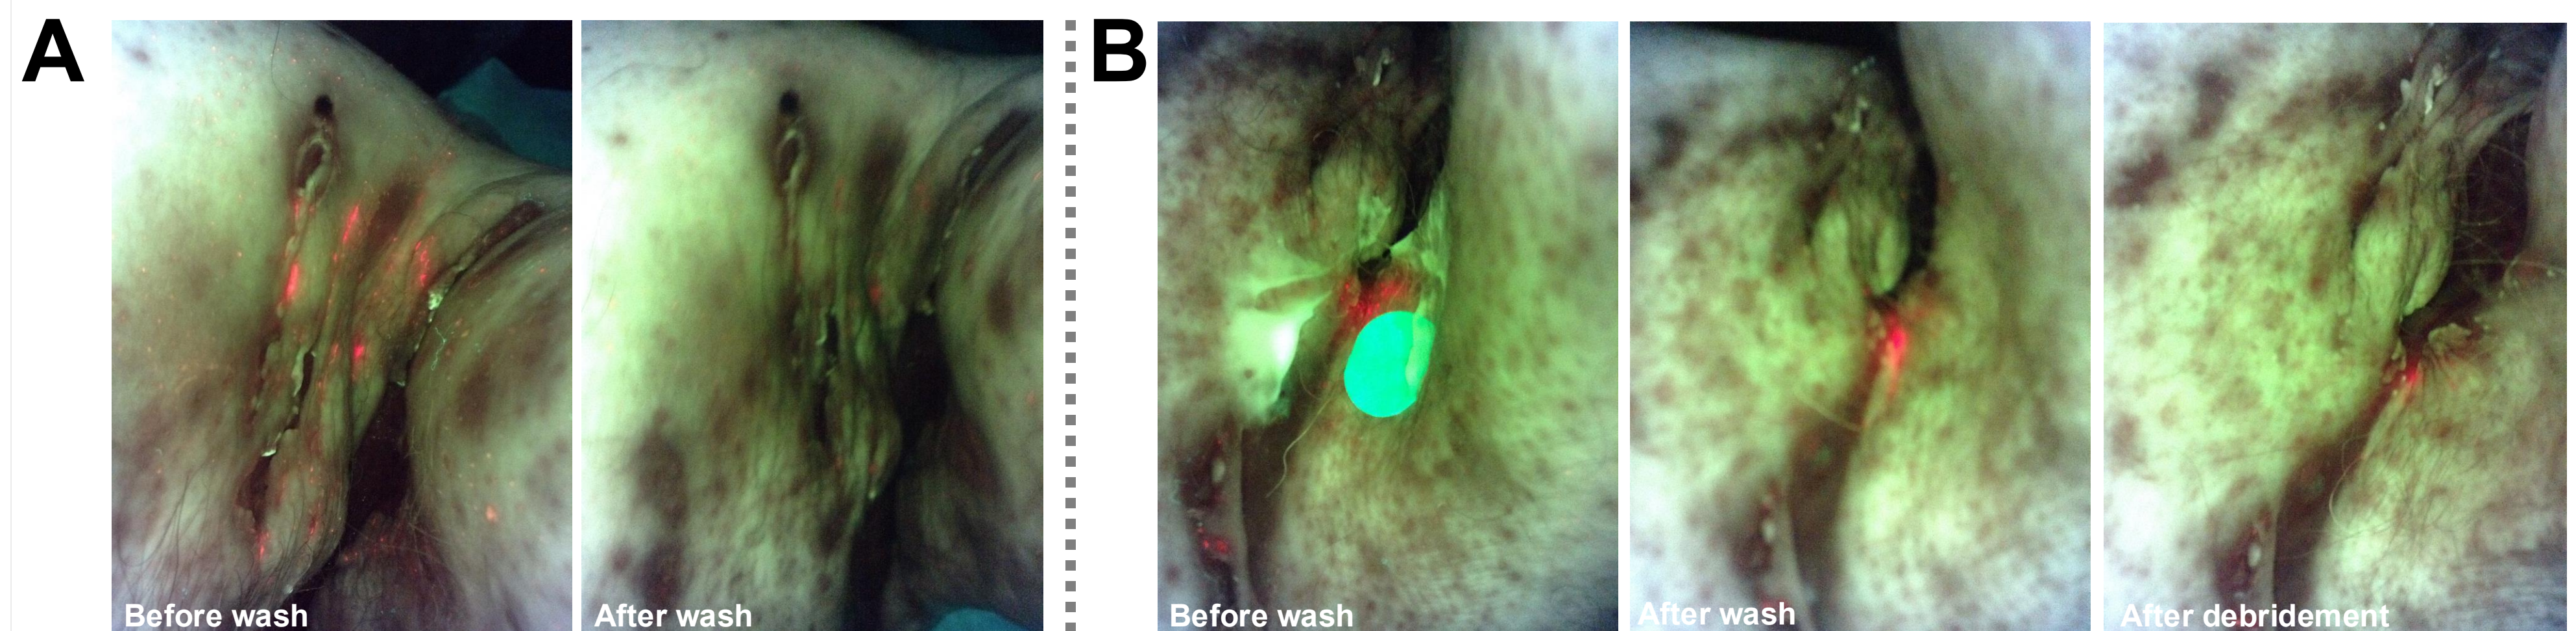
Case 2: Fluorescence-Guided Management of Chronic Left Axillary HS Wound

Case summary: 44-year-old male with chronic hidradenitis suppurativa presented with a persistent left axillary wound with areas of undermining and pain during wound care. (A) Fluorescence imaging showed red fluorescence in the left axilla, consistent with elevated bacterial burden. The wound was cleansed and scrubbed with Vashe, which led to a visible reduction in fluorescence, demonstrating the effectiveness of targeted cleansing in reducing bacterial burden. (B) At follow-up (7 weeks after last visit), fluorescence imaging again showed red and cyan fluorescence in the left axilla. Washing removed the cyan fluorescence but did not reduce the red signal, whereas mechanical debridement decreased the red fluorescence, indicating reduction of bacterial burden following escalation of intervention. At the last visit (12 months of follow-up), the wound had gradually improved with continued hygiene, antimicrobial dressings, and periodic debridement, while bacterial burden and infection risk were longitudinally monitored using fluorescence imaging with the MolecuLight i:X device.

Finding: Fluorescence imaging provided point-of-care visualization of bacterial burden and helped determine when cleansing was sufficient versus when escalation to mechanical debridement was required to reduce bacterial fluorescence.
