# Unintended Effects of a Groper Appliance: A Case Report

Kara Dern, DDS

University of Nevada, Las Vegas School of Dental Medicine

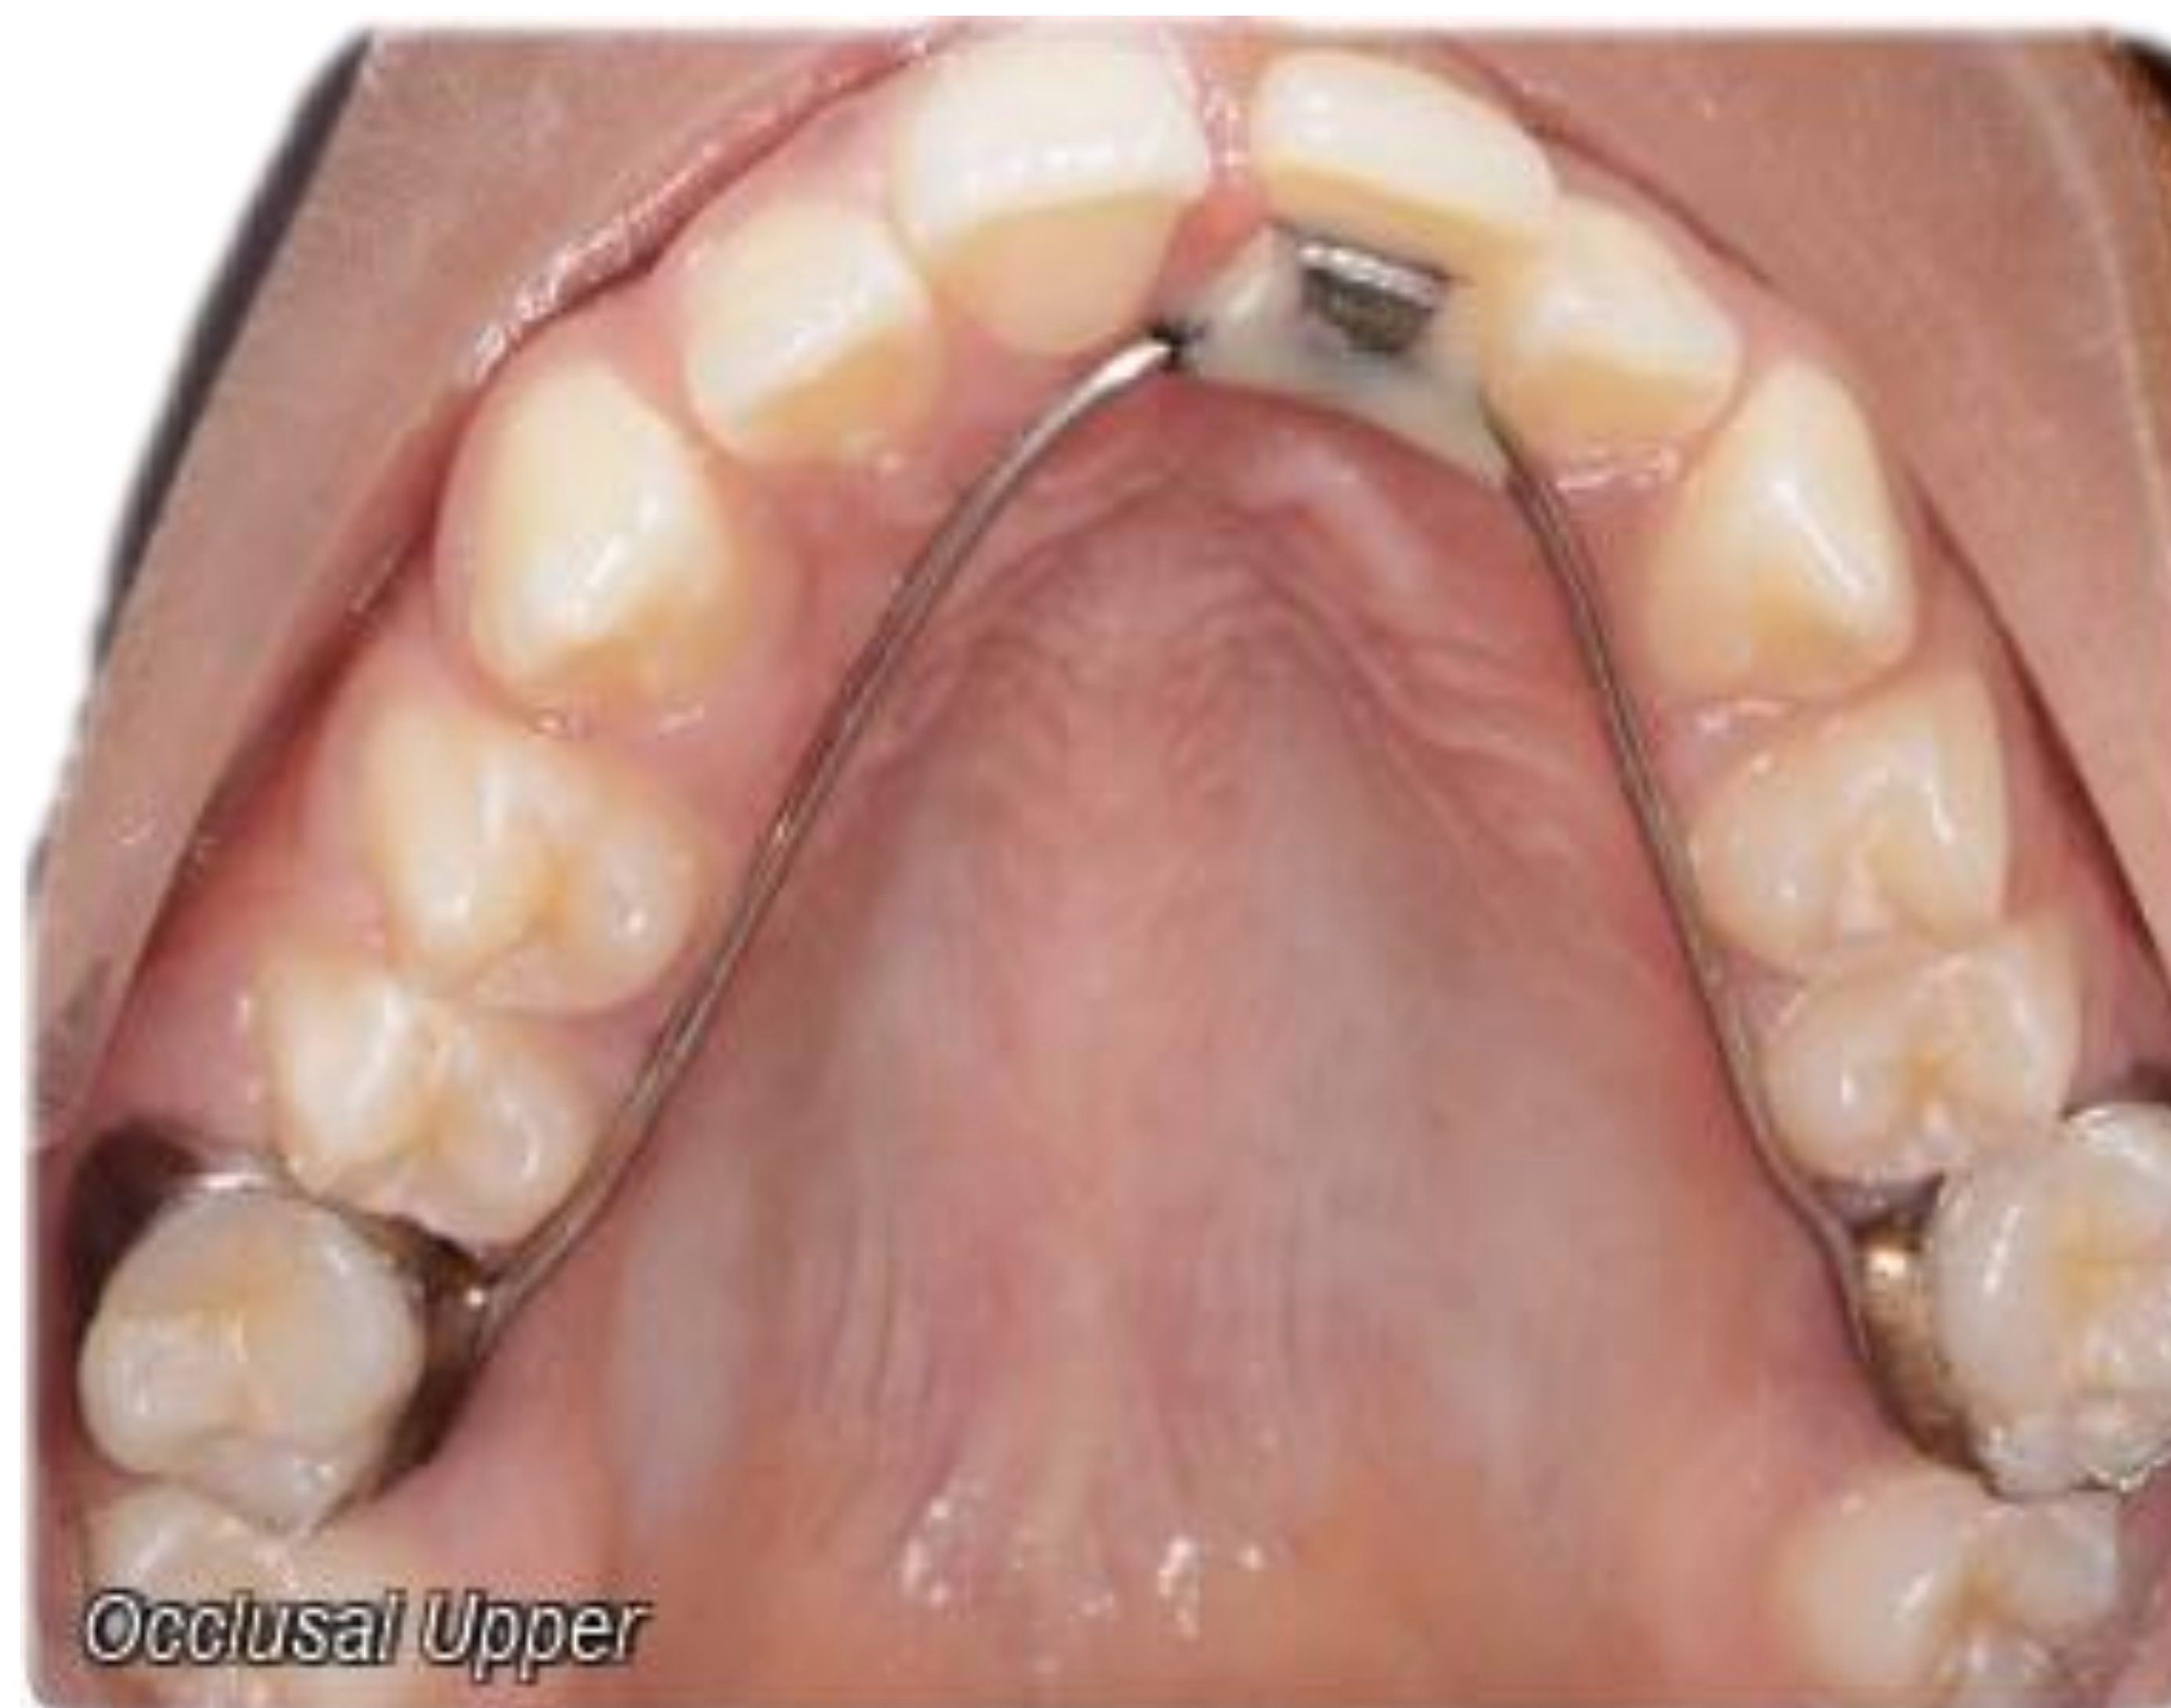
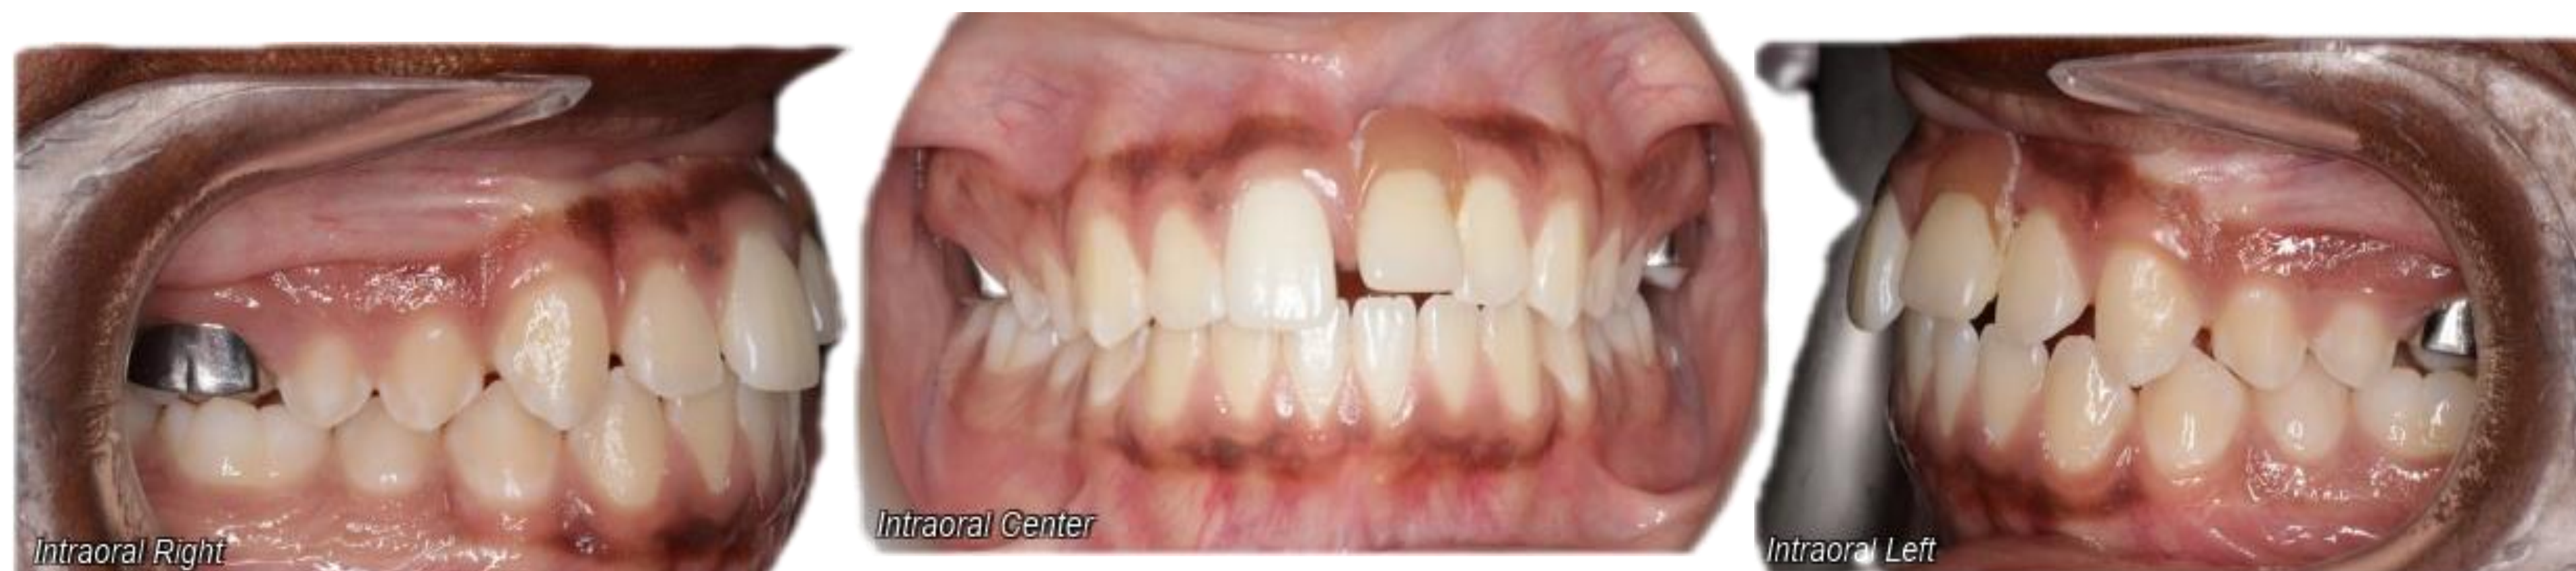
**Intraoral Evaluation:** An unaesthetic Groper appliance is present, replacing tooth #9, with a facially positioned pontic measuring approximately 5 mm shorter than tooth #8. The pontic is asymmetrically spaced and encroaches on the mesial aspect of tooth #10, where caries is present. A Siebert Class III ridge defect is noted at site #9. The patient exhibits a Class I molar relationship, with asymmetric facial displacement of the maxillary first molars relative to the normal arch form.

1. Remake Groper appliance
2. Removable interim partial denture
3. Resin-bonded FDP, one wing on #10 and maintain diastema
4. Comprehensive orthodontic treatment and resin-bonded FDP at completion

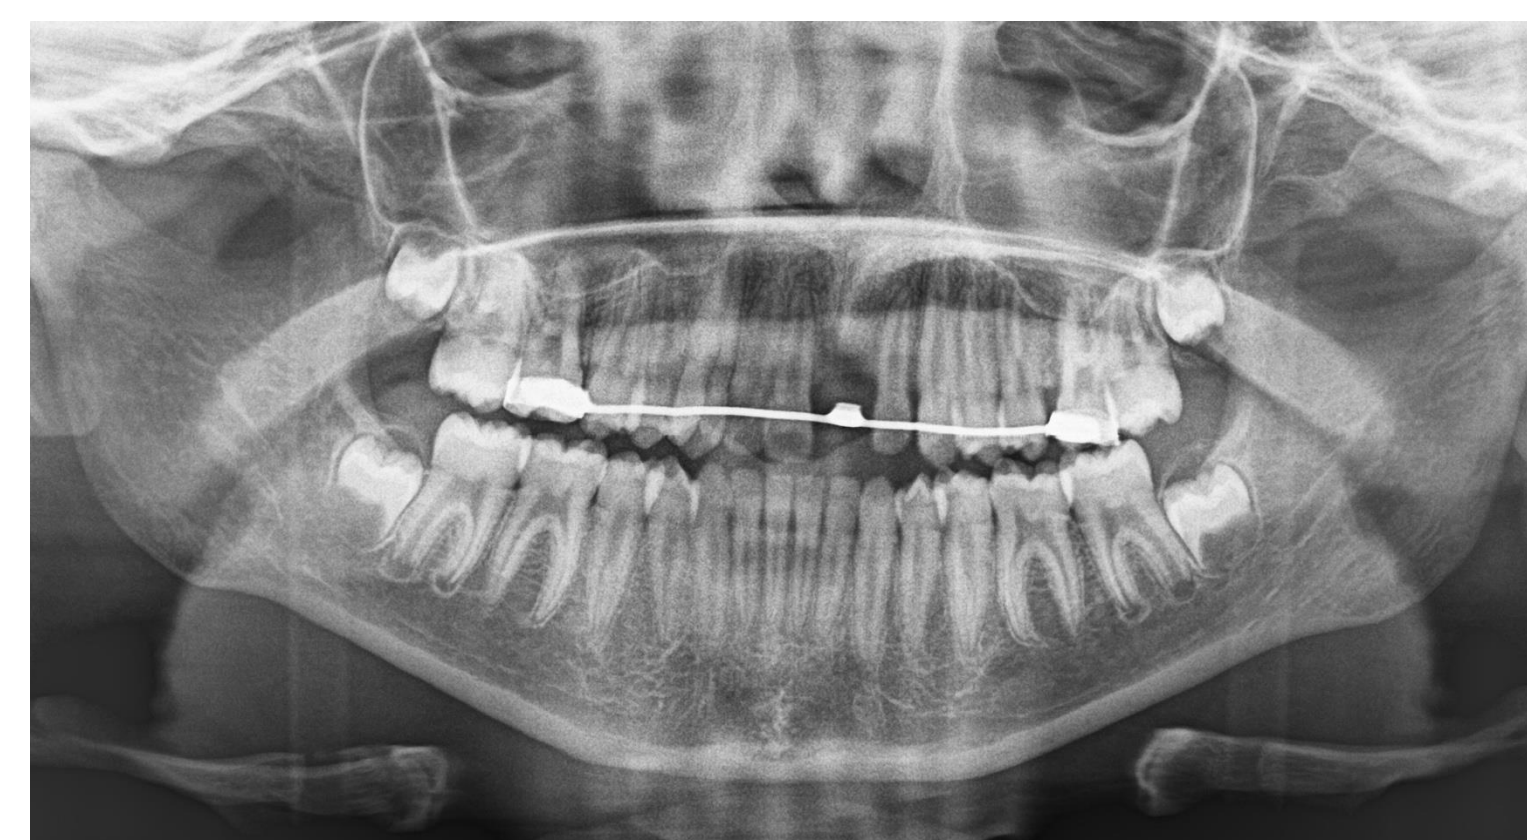
**Radiographic Evaluation:** Tooth #9 is missing, with evidence of horizontal alveolar bone loss.
